K32286rev.1

## TECHNICAL FIELD REPORT

2023-08-08

Re: Inspection and Damage Assessment of Genie Scissor Lift Following Unloading Incident, Provide General Repair and Further Disassembly Direction  
Model GS-3246, S/N GS4616P-139390, Unit 104088

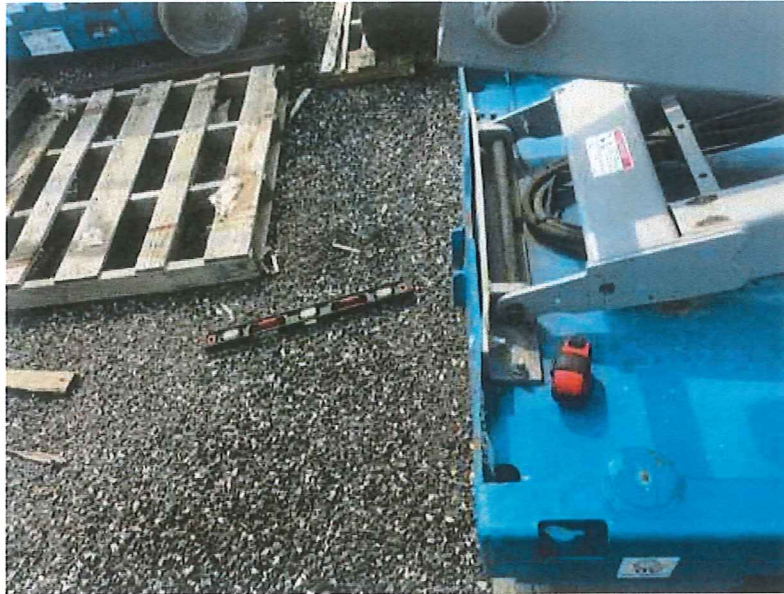
Figure 1: Location of Front Lower Damage

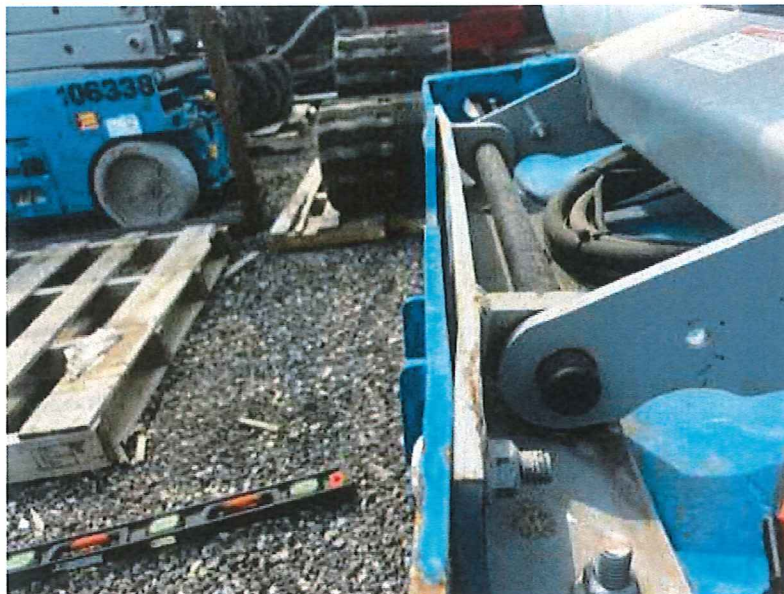
Figure 2: Bent Lower Lift Stage Mounting Bracket.

**Upper and Lower Lift Stage Mounting Brackets:** These mounting brackets and their associated pins, mounting hardware are to be replaced with new OEM components.

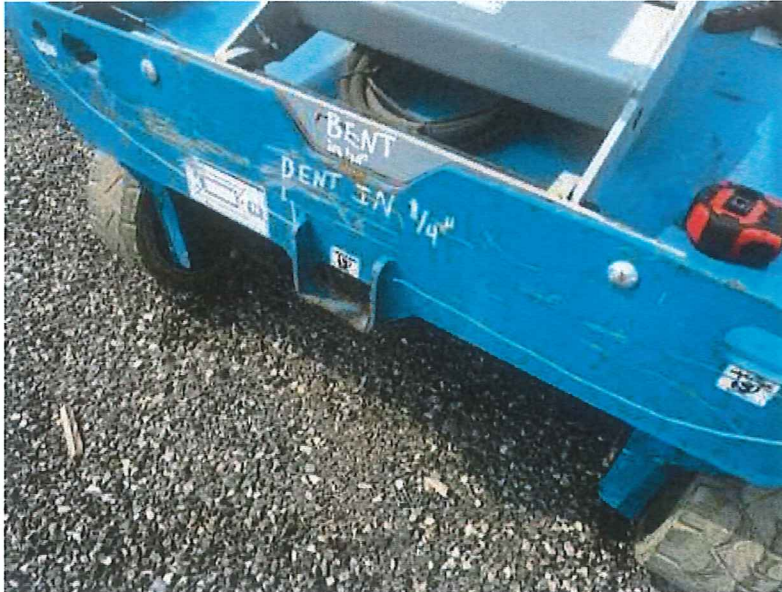
Figure 3: Bent Front Plate on Carrier Frame

**Carrier Front Plate:** In our opinion the bent carrier front plate will be difficult to straighten to within +/-1/16" tolerance as there is permanent yielding in the plate. Straightness in this plate is critical as the scissor stage mounting bracket and steering assembly connects to this bracket. Replacement of the front plate will likely be required. Plating replacement will likely need to be performed by a fabrication shop as the manufacturer won't provide just the replacement front plating. The replacement plate will need to be fabricated to match the original plate in the undamaged condition. Prior to providing replacement direction, we will need to perform hardness testing to confirm material specs. Disassembly of the scissor stage and steering assembly will be required to facilitate these repairs.

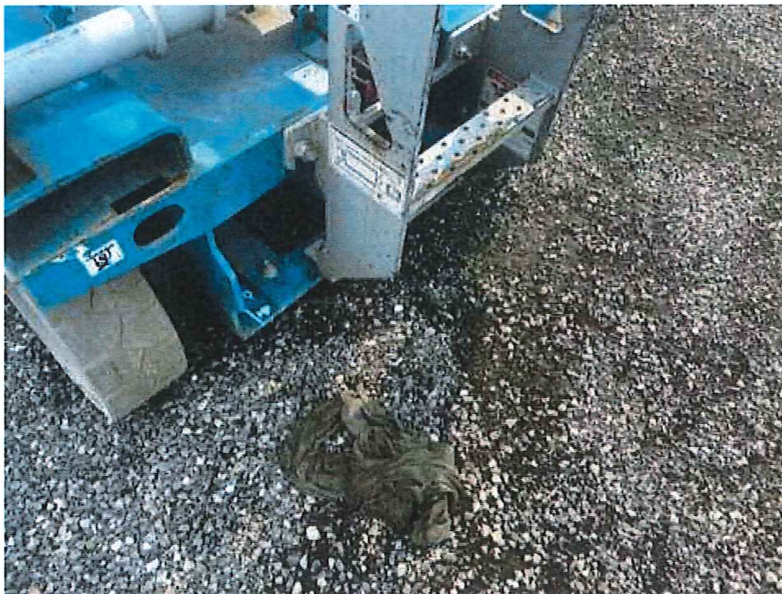
Figure 4: Bent Rear Plates on Lower Carrier Frame

**Carrier Rear Plates:** Attempt to cold-straighten bent rear plates to +/-1/16" tolerance. if unsuccessful, replacement of the plates will be required. Refer to above for description of replacement. The ladder must stand vertical following cold-straightening repairs.

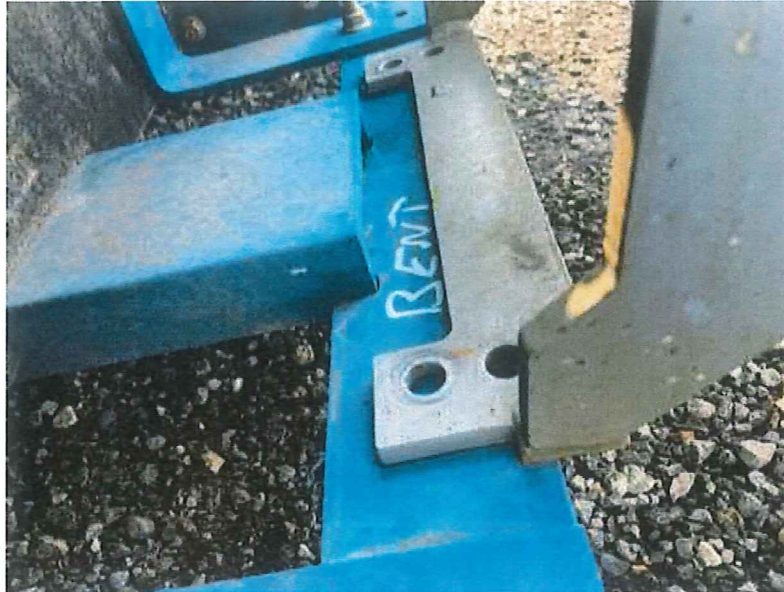
Figure 5: Bent Rear Lower Plate on Lower Carrier Frame

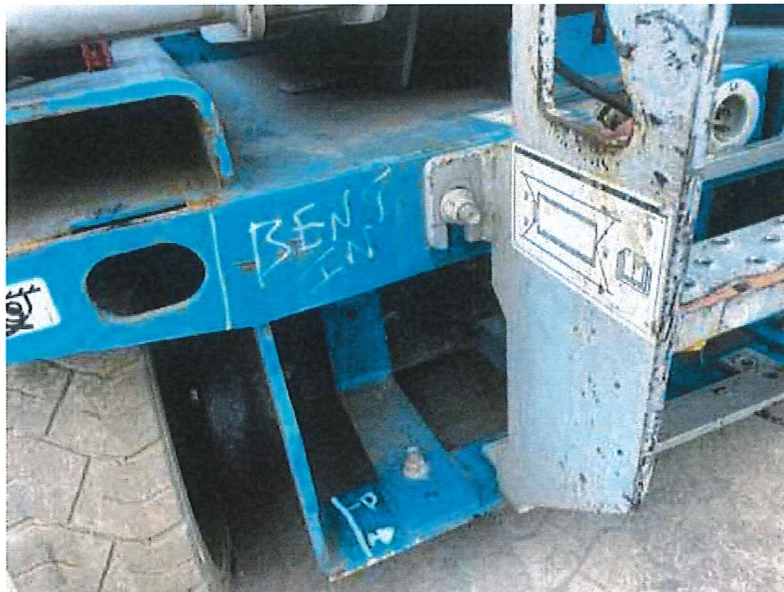
Figure 6: Bent Location.

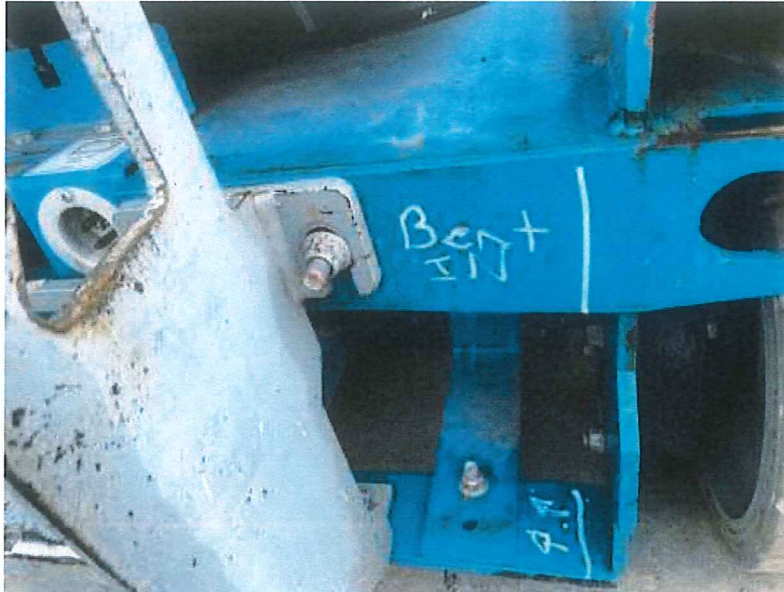
Figure 7: Bent Location.

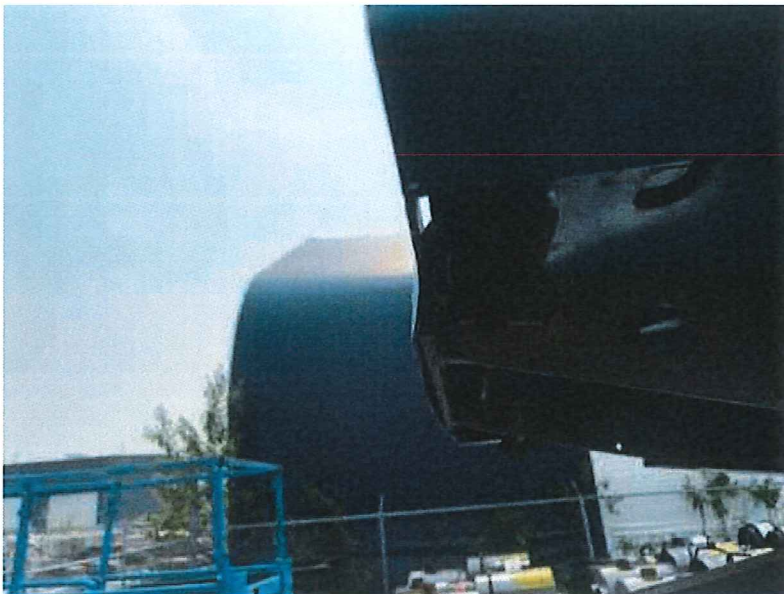
Figure 8: Bent Upper Lift Stage Mounting Bracket.

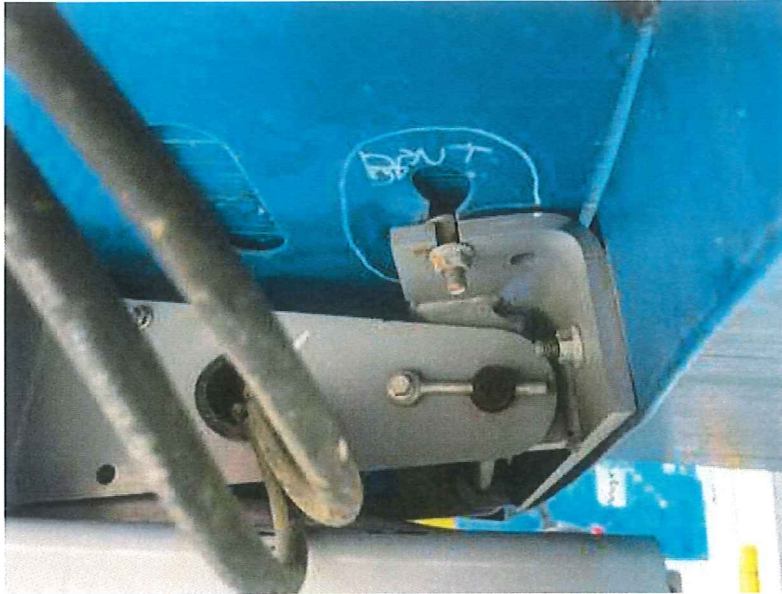
Figure 9: Bent and Torn Location, Upper Mounting Bracket to Platform.

**Front Platform Skirt and Mounting Area:** These areas are locally deformed and stretched, the damaged sections will need to be cut out and replaced with new sheeting. Sheeting replacement will likely need to be performed by a fabrication shop as the manufacturer won't provide just the replacement sheeting. The replacement sheeting sections will need to be fabricated to match the original sections in the undamaged condition. Prior to providing replacement direction, we will need to send a coupon sample to a materials lab for them to perform hardness testing to confirm material specs. Disassembly of the platform will be required to facilitate these repairs.

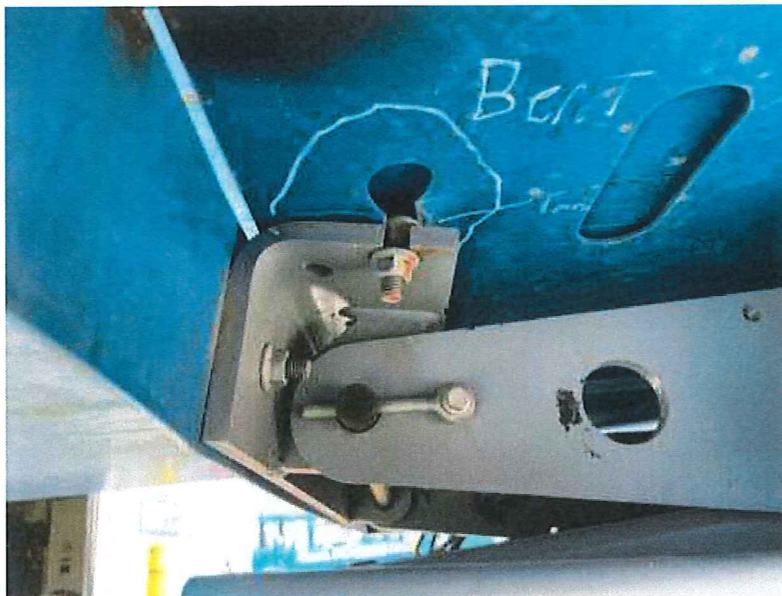
Figure 10: Bent and Torn Location, Upper Mounting Bracket to Platform.

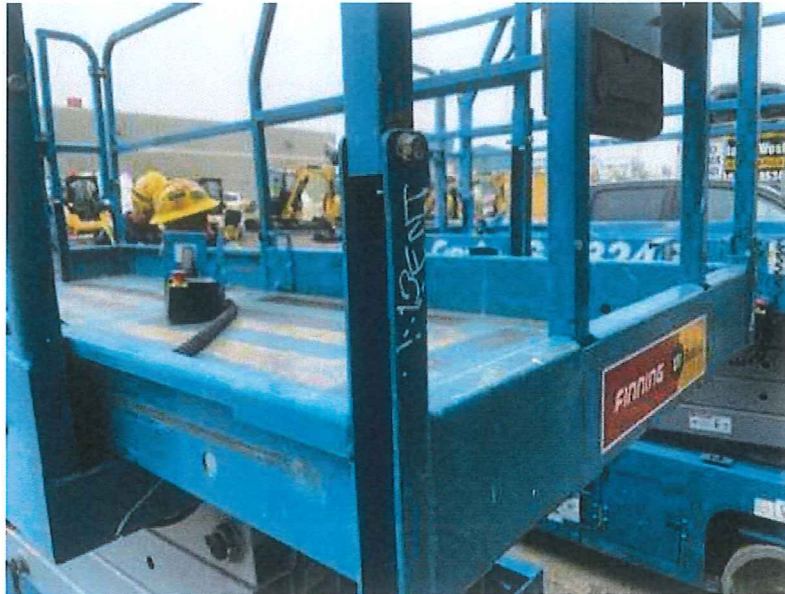
Figure 11: Bent Platform Member.

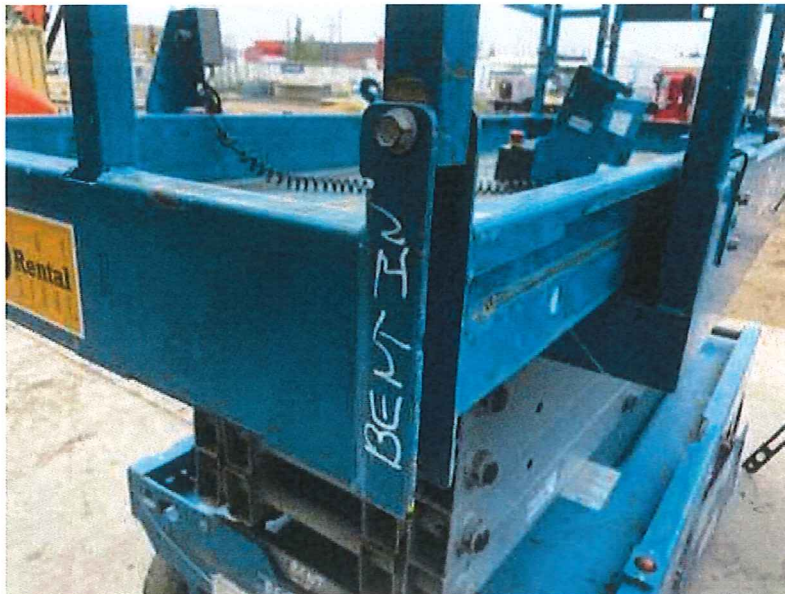
Figure 12: Bent Platform Member.

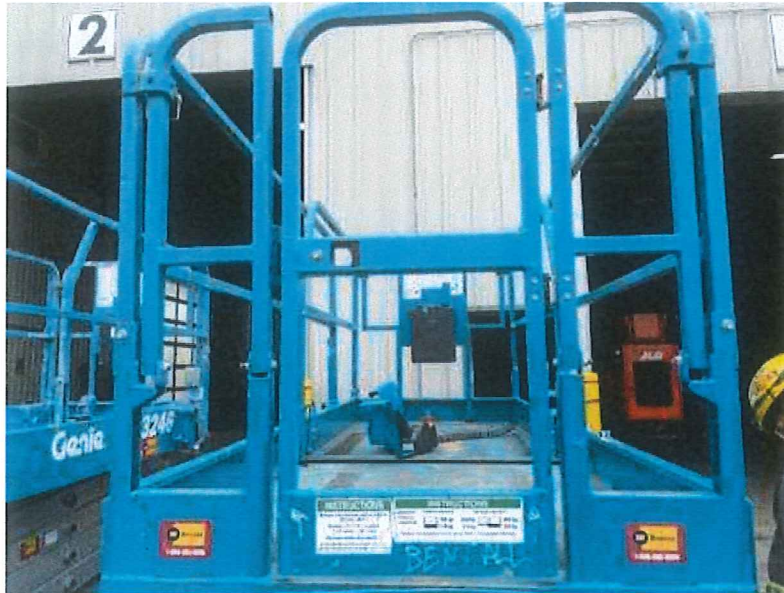
Figure 13: Bent Access Gate.

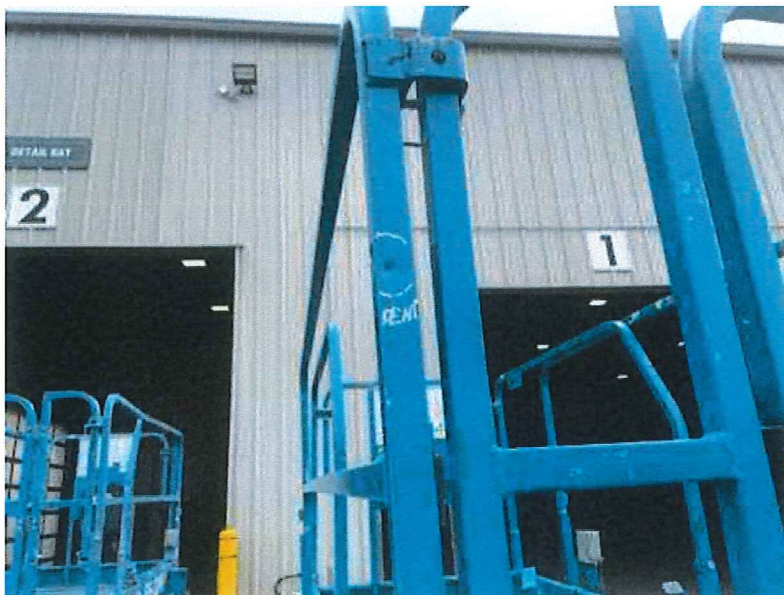
Figure 14: Dented Location on Platform.

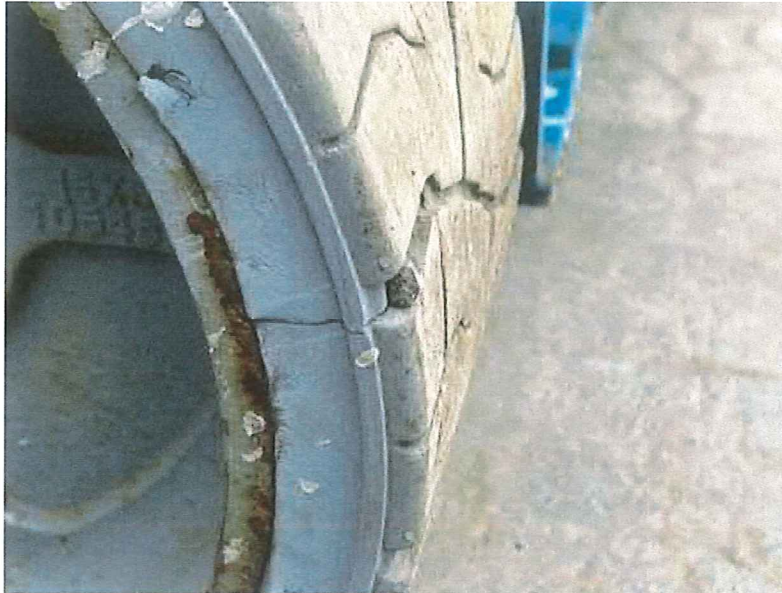
Figure 15: Crack/Impact Location on Rear Drive Wheel.

**Rear Wheel Assemblies:** Have qualified mechanical personnel disassemble and inspect both rear wheel rims, associated hubs and spindles. If there are damages and/or if these components are not within manufacturer's tolerances, replace with new OEM components. All hub and wheel mounting fasteners are to be replaced with new OEM components. Kova South to inspect the mounting areas on carrier frame once these components have been removed.
