SITE VISIT REPORT

FILTERBOXX WASTEWATER TREATMENT PLANT INSPECTION

Kevin Slough | NuTangent Technologies | April 14, 2020

Prepared for Durum Capital

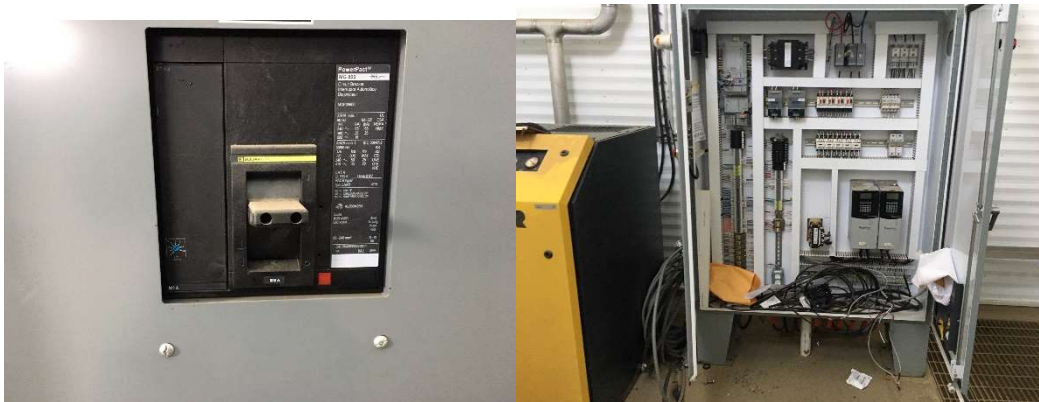
A secondary concern is accumulation of dust within the panel components. Most of the panels appeared to be free of signs of significant dust accumulation but several panels were either left open or were of a type that did not seal and had significant dust evident.

It is recommended that the electrical panels be blown out with dry air prior to being placed into service.

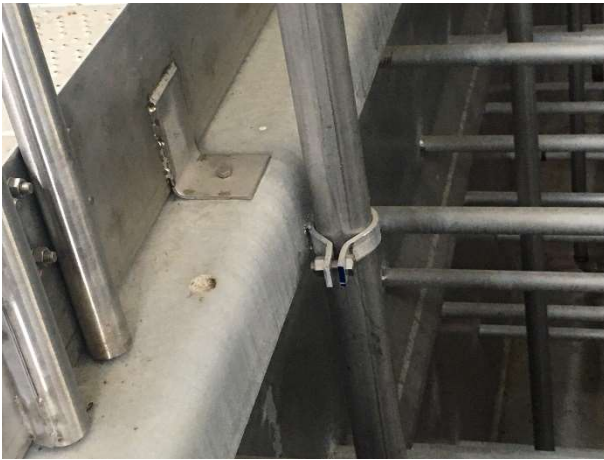
During the site inspection, it was observed that there is direct contact between these dissimilar metals within the process tanks of the wastewater treatment plant both above and below the waterline. In some cases there is isolation in place between the two dissimilar metals and in other cases there is direct metal-metal contact.

No pipe isolation present.

It is recommended that at a minimum, in cases below the waterline and where there are process connections below the waterline, that isolation/insulation be installed. This would include pipe wraps where stainless pipe is in contact with aluminum pipe supports and bolt isolation kits on flanges. As a further precaution an electro-galvanic protection system can be installed.

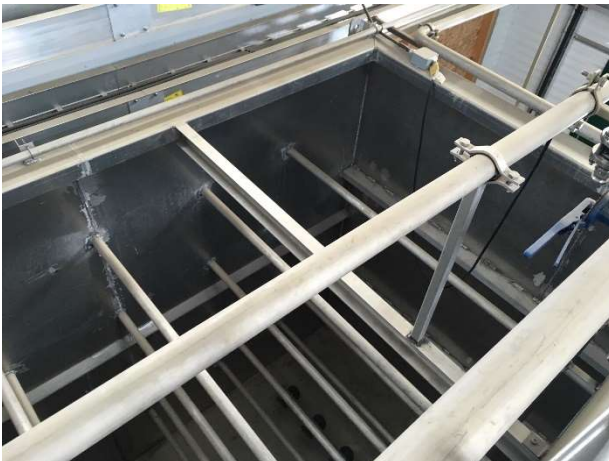
Pipe isolation present.

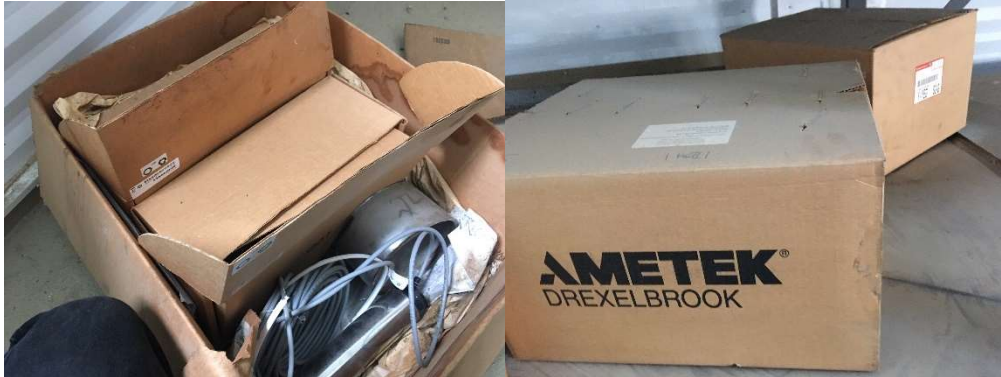
There are several boxes of loose shipped equipment. Including the dissolved probes for the bioreactors as well as tank level transmitters. It is recommended that this equipment be secured in some fashion as site access is relatively uncontrolled and the buildings are open.

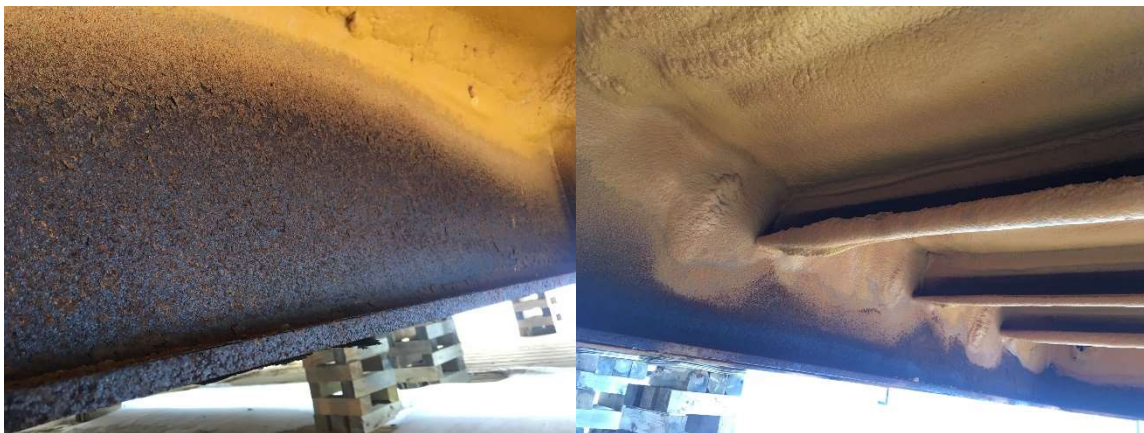
The majority of the skids are primarily supported only on the outside perimeter beams with some skids having partial support under mid-beams. However, there appears to be no noticeable skid deflection. Skid lifting lugs are still in place. The skids have external connection points for access stairs but no stairs were observed on site. There are also should be interconnecting platforms that connect doorways of each of the individual skids. These also appear to be missing. Its possible they as well as the stairs were set aside elsewhere onsite and possible covered with snow.

The underside of the beams show surface rust with no observed evidence that the underside of the beams received protective paint coating. The underside of the skids has been sprayfoamed to provide floor insulation but the installation of the spray foam does not appear consistent in its application.

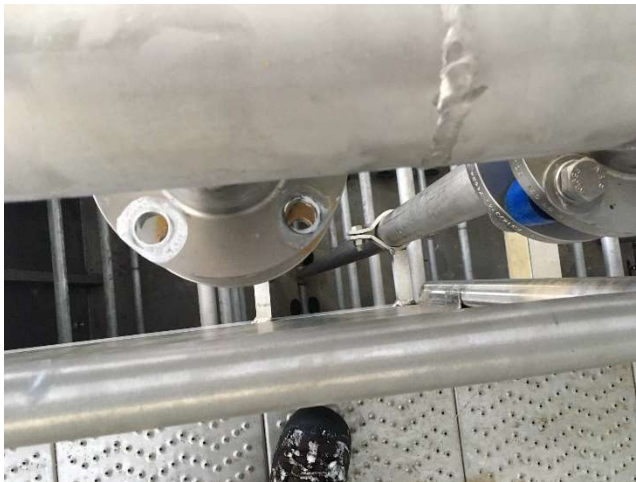
The equalization tank is 56' long, 12' wide and 10' in height with a volume of 190 m³. The tank is of aluminum construction. The tank is equipped with stainless steel aeration piping and coarse bubble diffusers. The aeration piping is not consistently isolated from the aluminum piping supports. The air flow to each of the aeration droplegs is controlled via a butterfly valve. One of the dropleg butterfly valves is missing. Although the diffusers are older than the typical replacement period for EPDM diffusers, since the diffusers have not been put into service and have been maintained indoors, it is expected that the diffusers will still operate effectively.

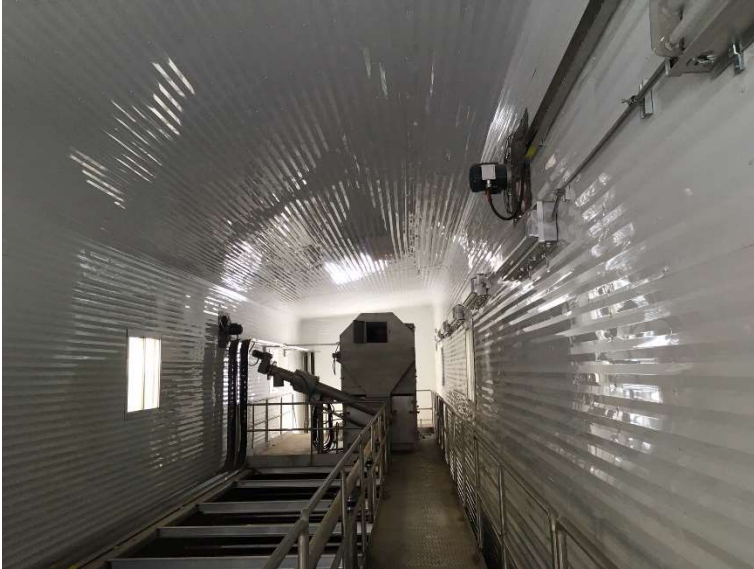
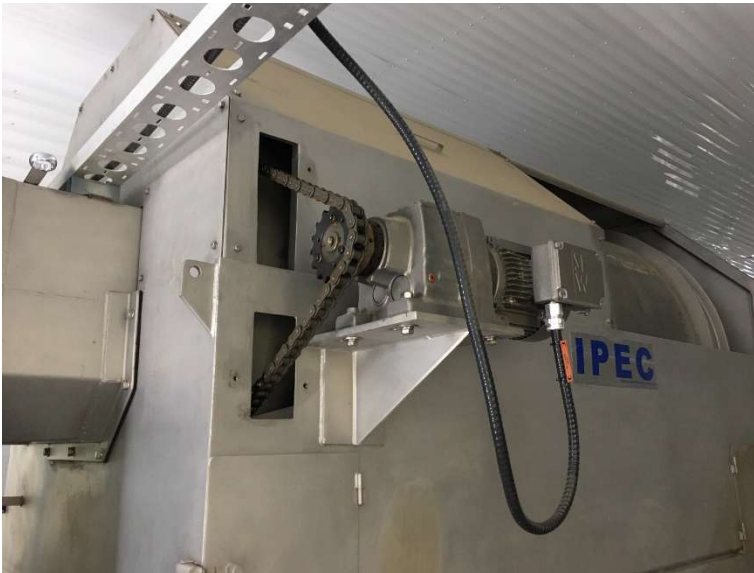
The inlet screen is an IPEC Model IFM 4872 Rotary Drum screen with stainless steel drum and frame construction. The drum screen appears to be in excellent condition. One of the screen access panels and the chain guard were removed at some point but were located next to the screen. The gear motor turned freely when the motor was turned by hand.

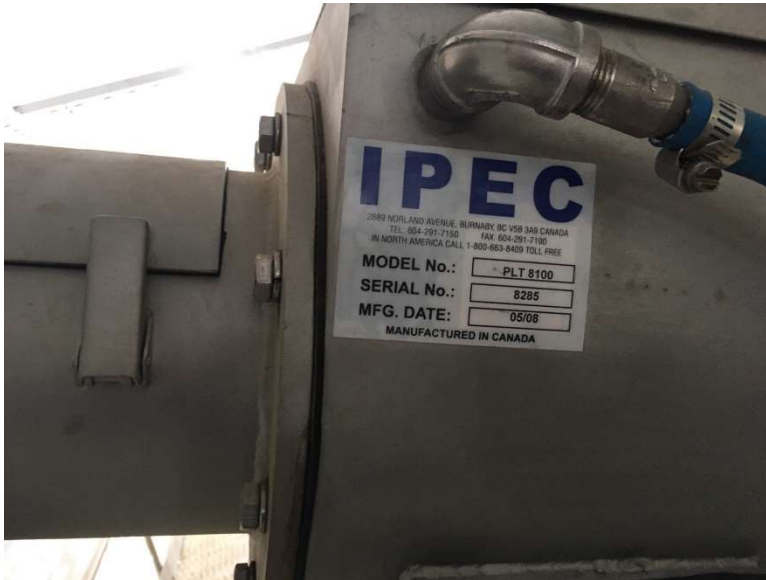
The screenings washer/compactor is an IPEC model PLT 8100 with stainless steel construction and stainless steel screw-auger. The unit appears to be in excellent condition. The gearmotor appeared to turn freely when the motor was rotated by hand.

As mentioned above, rotating equipment should be checked by a millwright to ensure shaft alignment and that bearings have not been flattened by prolonged storage with no periodic rotation or lubrication.

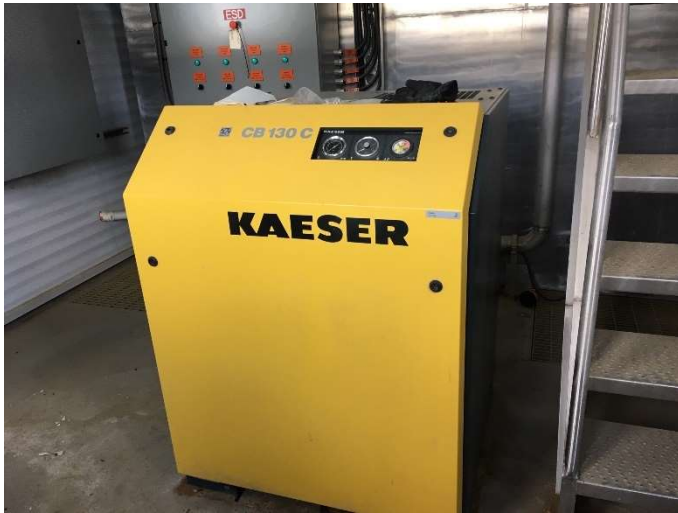
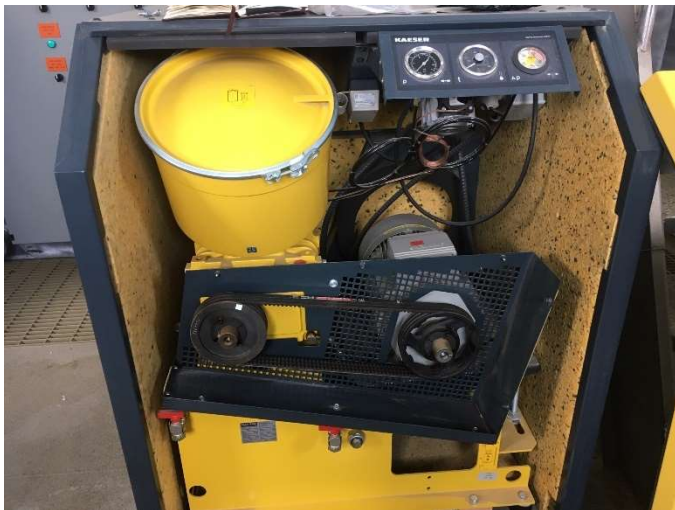
Process air is discharged to the Equalization Tank to provide mixing and to ensure that the inlet sewage does not become septic. The process air is supplied by a Kaeser CB130 C rotary lobe blower with acoustic enclosure. The process air blower appeared to be in excellent condition. No seal/oil leaks were observed, the drivebelts appeared in excellent condition and the blower rotated freely when rotated by hand. It should be noted that the drive belts on the blower were tensioned whereas it is more commonly recommended practice to relieve the tension on drive belts when equipment is placed in storage. The oil level was good and the oil looks pristine.

As mentioned above, rotating equipment should be checked by a millwright to ensure alignment and that bearings have not been flattened by prolonged storage with no periodic rotation or lubrication.

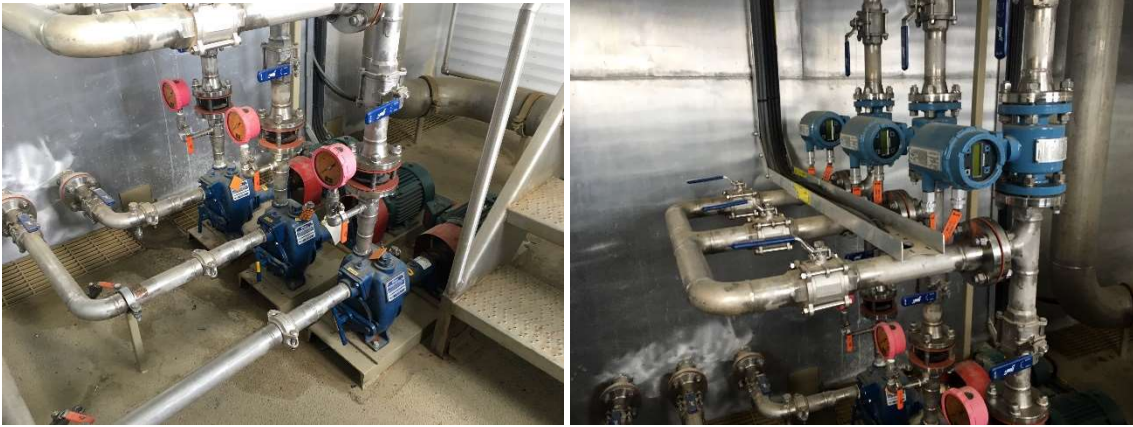
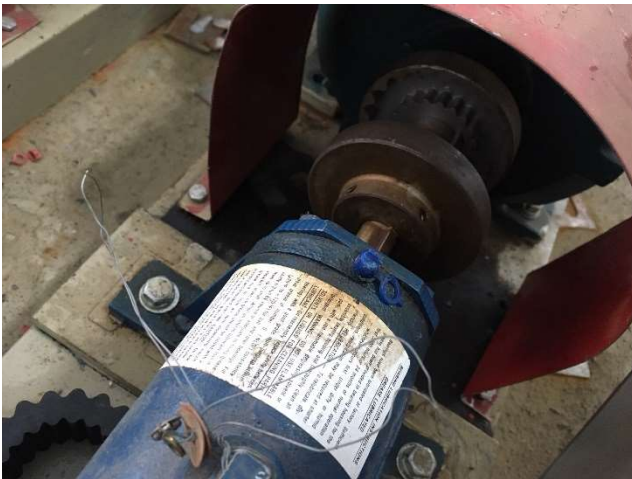
One of the pumps has the drive coupling disconnected and missing. Two of the pumps (1 and 3) have a noticeable 'scrapping' noise and feel when the rotated by hand likely

indicative of some bearing damage. These pumps should definitely be inspected by a millwright to ensure alignment and to inspect/replace bearings and seals.

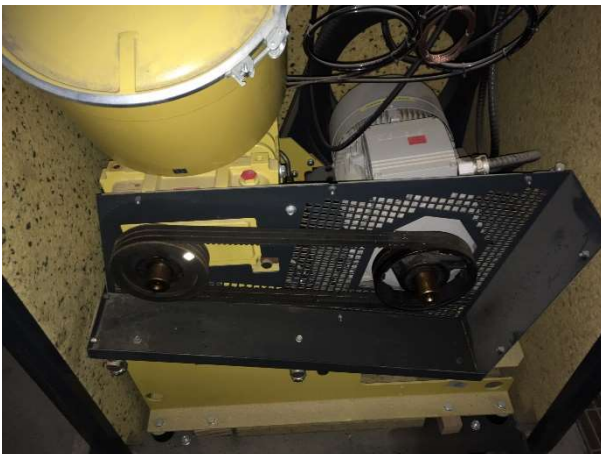
The process air blowers all appear to be in excellent condition. The blowers all turn smoothly when rotated by hand. Oil levels and condition appear excellent. Drive belts appear to be in good condition.

It should be noted that the drive belts on all the blowers were tensioned whereas it is more commonly recommended practice to relieve the tension on drive belts when equipment is placed in storage.

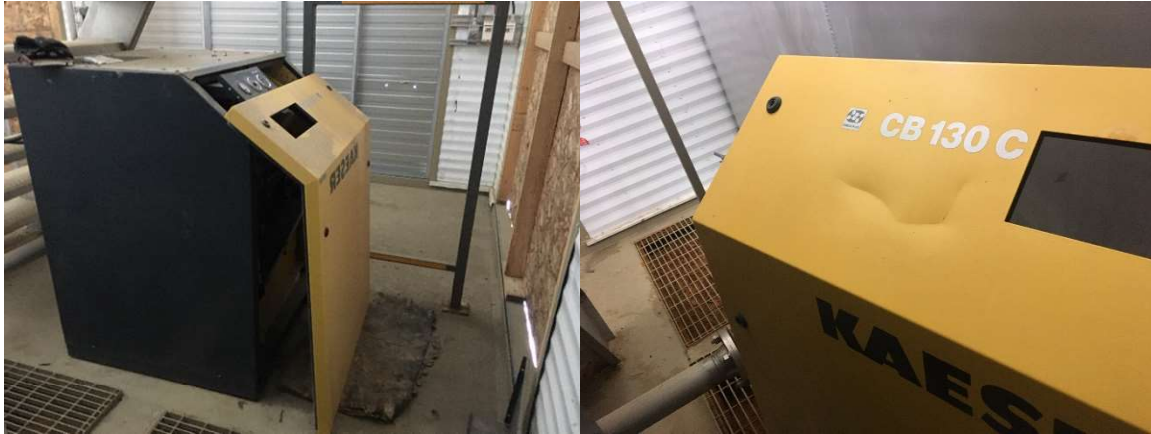
The acoustic enclosure on the process air blowers on bioreactor skid 1 and skid 3 were both removed at some time prior to inspection. And one of the blower enclosures has suffered some minor cosmetic damage.

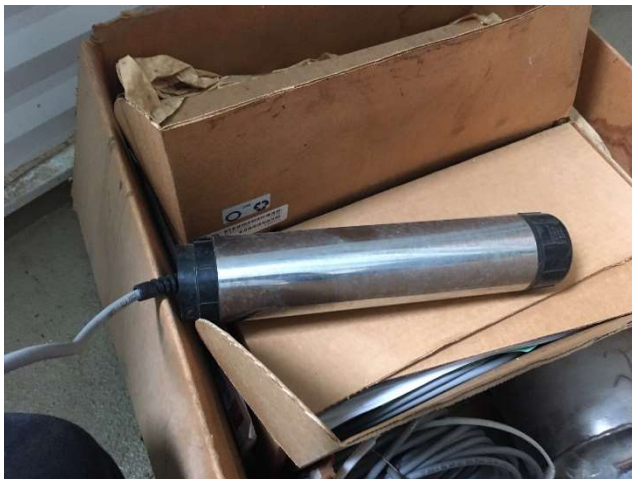
The dissolved oxygen LDO probes have never been installed and remain within their original boxes within Bioreactor 1 building although one box has been opened. It should be noted that although these probes were never placed into service, the probe sensor have exceeded their expected life and may not function once placed into service. The LDO probes themselves are also obsolete and have been replaced by the LDO₂ probes from HACH. At this time, it is not known if sensor caps or other spares for these probes are available.

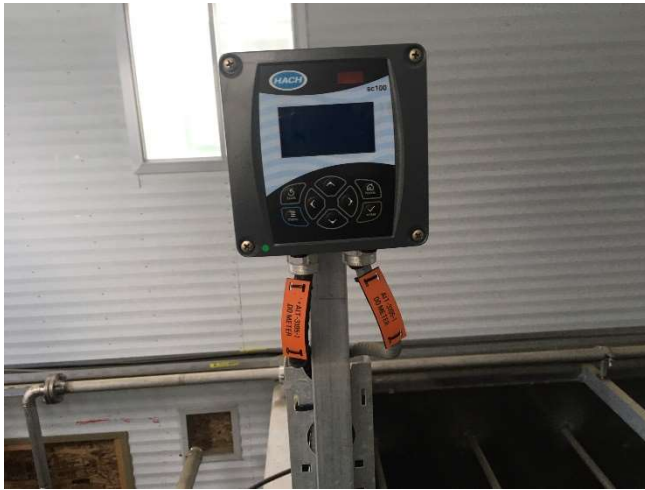
The HACH SC₁₀₀ controller has also been replaced by the SC₂₀₀ controller. The SC₁₀₀ was a universal controller capable taking input from a variety of instruments. It is

expected that the SC100 controller should still be capable of use with new LDO₂ probes if it is necessary to replace the probes.

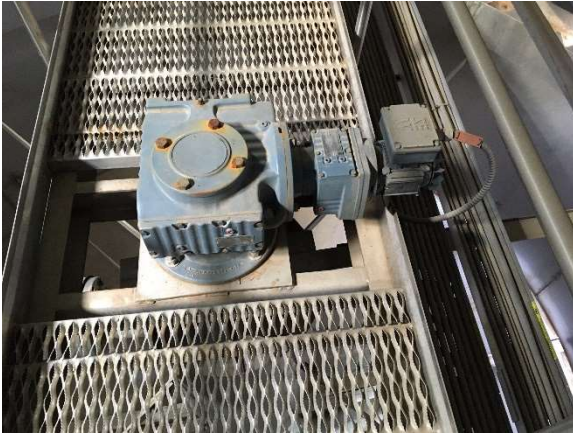
The clarifiers themselves appeared to be in excellent condition with no damage or corrosion observed. The rubber on the sludge scrapper/skimmer appeared to be in good condition. The sew eurodrive gear motors on each of the clarifiers turned freely when

rotated by hand. However, it should be noted that the fan covers for the gear motors had been removed prior to the time of inspection and were not seen onsite. There is minor corrosion present on the housing bolts but is largely cosmetic.

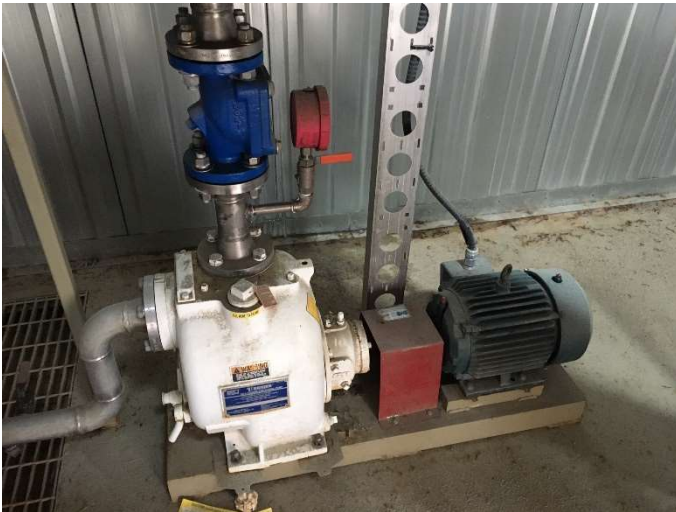
Like the feed pumps, all of the sludge return pumps had noticeable scrapping' noise and feel when the rotated by hand likely indicative of some bearing damage. These pumps should definitely be inspected by a millwright to ensure alignment and to inspect/replace bearings and seals.

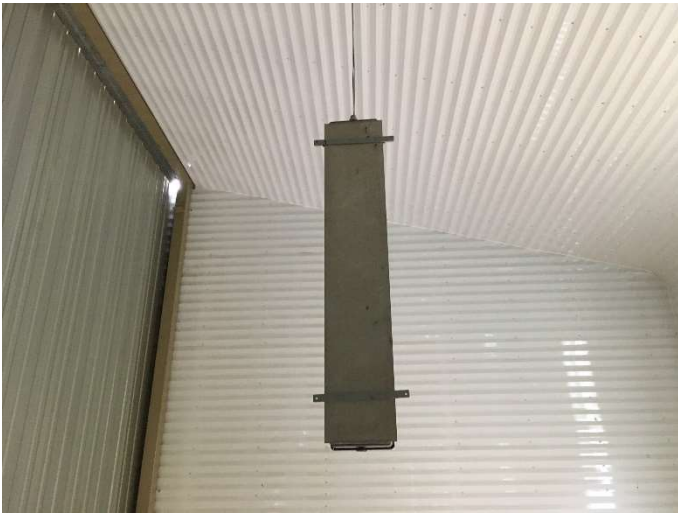
One of the lights in the clarifier building has become dislodged from its ceiling attachment and is hanging by its wire. This should either be reattached or disconnected prior to moving the wastewater treatment plant to its final location.

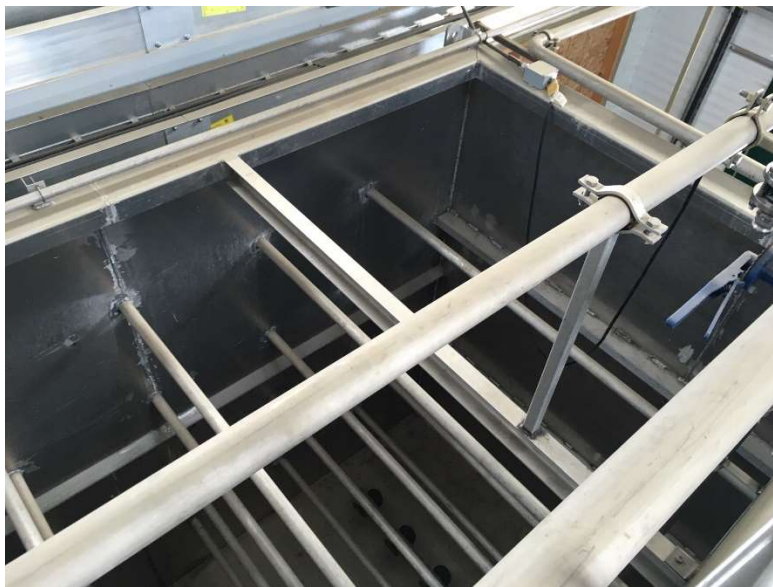
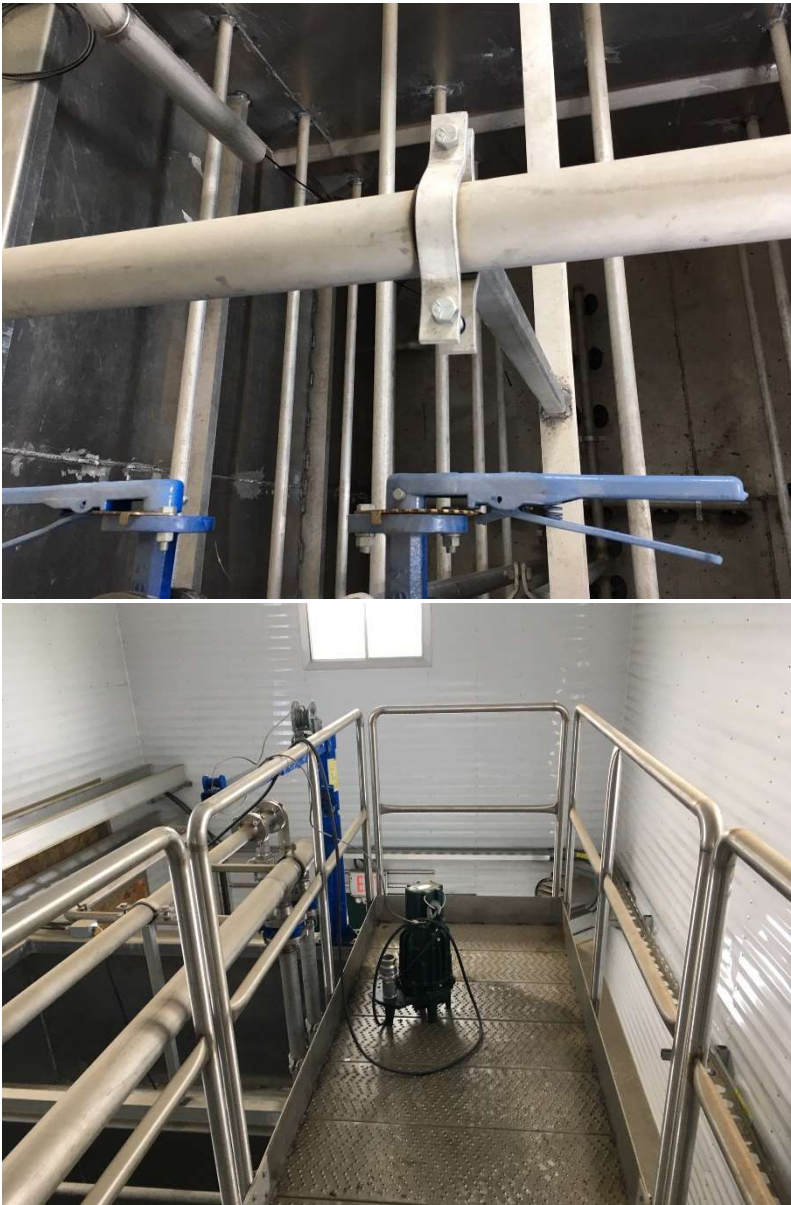
The sludge digester appears to be in excellent condition. No damage or corrosion was observed. The digester is equipped with stainless steel aeration piping with drop legs descending into the digester tank equipped with coarse bubble diffusers. As mentioned previously for the equalization tanks and bioreactors, there is potential for dissimilar metal corrosion on this system once it is placed in service. There will at a minimum require isolation between the stainless steel aeration piping and the aluminum pipe supports attached to the digester tank. Some of the connections are isolated with rubber pipe wraps but it appears to be inconsistently employed. The air flow to each of the aeration droplegs is controlled via a butterfly valve. Although the diffusers are older than the typical replacement period for EPDM diffusers, since the diffusers have not been put into service and have been maintained indoors, it is expected that the diffusers will still operate effectively.

The decant pump and davit are present. The decant pump should be removed and secured prior to movement of the wastewater treatment plant.

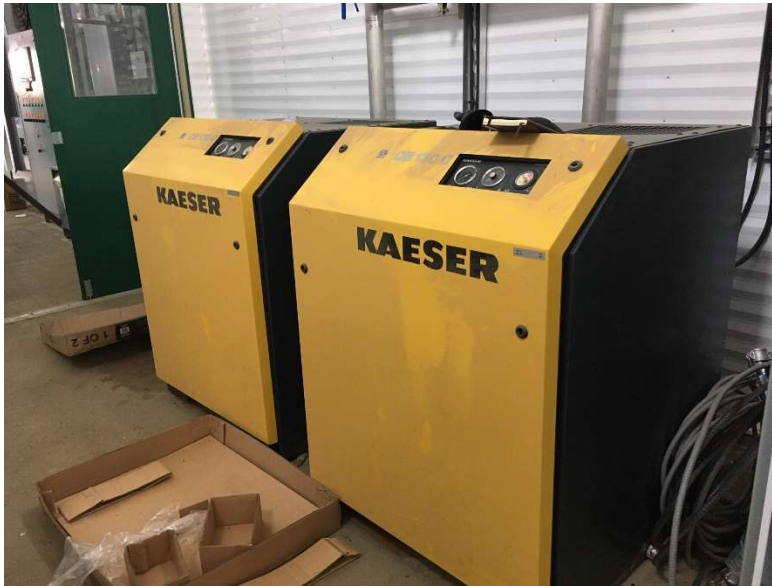
The process air blowers are two Kaeser CB130 C rotary lobe blowers with acoustic enclosures. The process air blowers both appeared to be in excellent condition. One of the check valves are missing from one the blowers. No seal/oil leaks were observed, the drivebelts appeared in excellent condition and the blower rotated freely when rotated by hand. It should be noted that the drive belts on the blower were tensioned whereas it is more commonly recommended practice to relieve the tension on drive belts when equipment is placed in storage. The oil level was good and the oil looks pristine. As with the other blowers, these should be inspected by a millwright to ensure bearings are not damaged prior to the equipment being placed into service

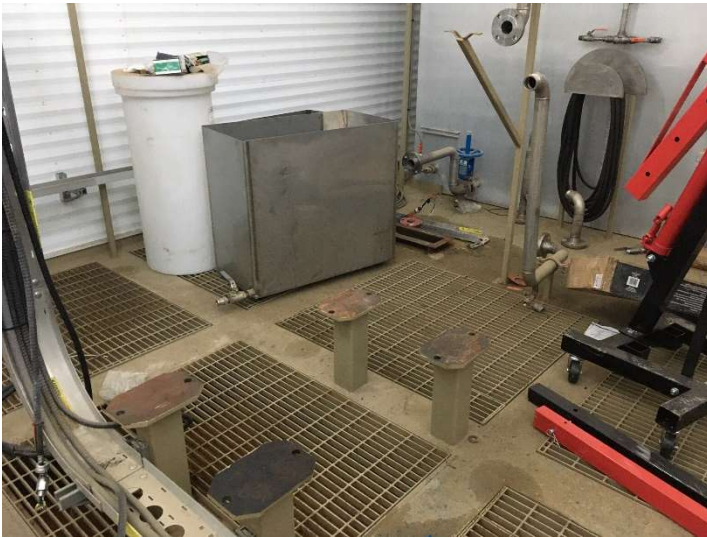
The wastewater treatment plant was originally equipped with a centrifuge dewatering package that included a Peiralsi Baby centrifuge, Polymaster polymer make-up system, polymer dosing, pump, progressing cavity type centrifuge feed pump and main control panel. With the exception of the main control panel the entire dewatering package is missing. The panel was left wide open and is filled with dust but otherwise appears in good condition.

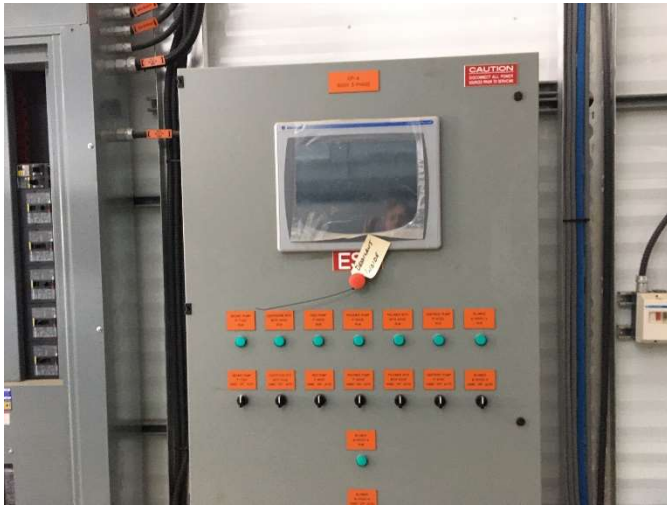
The wastewater treatment plant is controlled via the main control panel/HMI system. The main control panel houses the Allen Bradley Compact Logix PLC along with input/out modules as well as the Panel View touchscreen HMI. The HMI provides access to the graphic user interface through which the operator controls the operation of the wastewater plant.

The main control panel appeared to be in excellent condition.

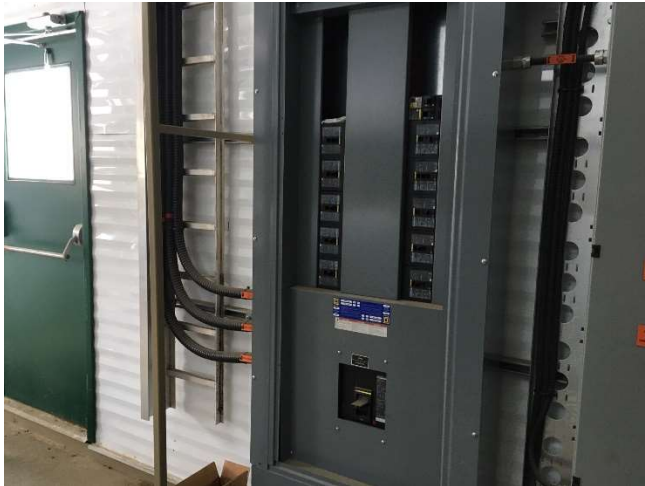
Apart from seemingly missing the breaker cover panel and accumulated dust. The main power panel appeared to be in excellent condition.

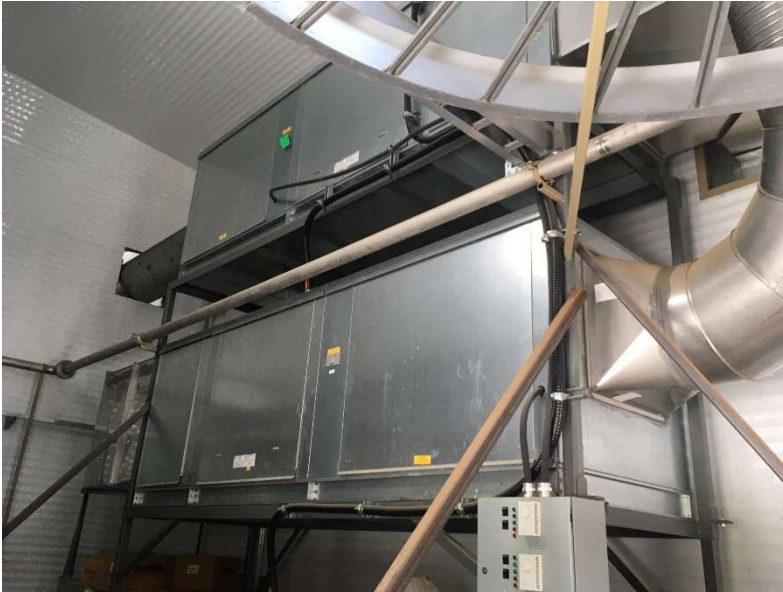
the central Make-Up Air Unit. The Make Up Air Unit is essentially a large ventilation fan combined with a large electric furnace. The circulation air is distributed among the equipment skids of the wastewater treatment plant via a system of air plenums.
